**Surface Water Assessment Report for the
West Carleton Environmental Centre Landfill**

AECOM

60289364

July, 2014

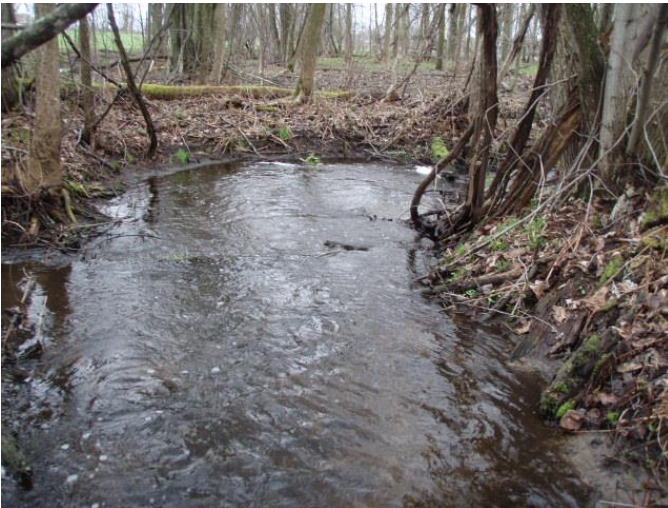
Tributary A originates south of Highway 417 and flows northwesterly through the Goulbourn Wetland. This tributary possesses a relatively natural channel form typically 1.0-1.5 m wide with 10 to 15 mm of flowing water on average over much of its length (**Plates 1 and 2**). It is generally situated within woodlands although portions pass through areas of open and active agricultural use. Specifically, cattle grazing and pasture lands. Tributary A provides habitat suitable for supporting a bait and forage fish population, although AECOM did not observe fish during their field reconnaissance. Bottom substrates were largely clay and sand/gravel within the reach. The channel also contained instream structure such as gravel areas, boulders and woody debris; features important to fish for feeding, rearing and cover. Flows at the time of assessment were abnormally elevated, however its hydraulic connection to wetlands likely provides sufficient baseflow to sustain water year round and even in low water years, there are adequate refuge pools to sustain small fish groupings.

Plate 1. Natural channel within Tributary A showing pool/glide habitats within wooded area

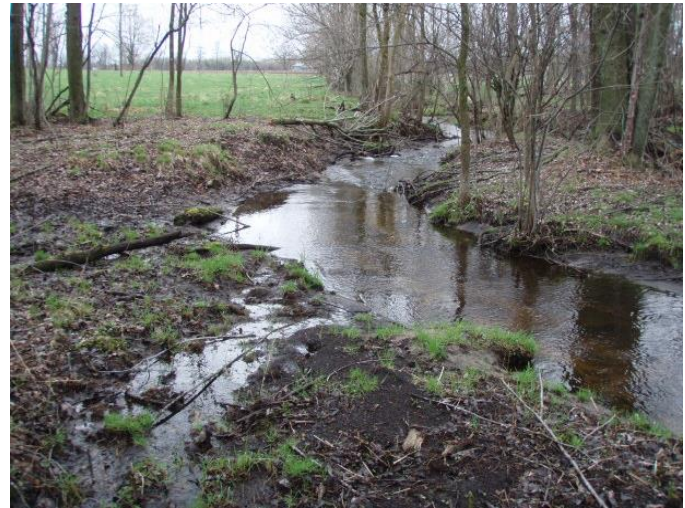
Plate 2. Tributary A passing from wooded area into pasture lands.

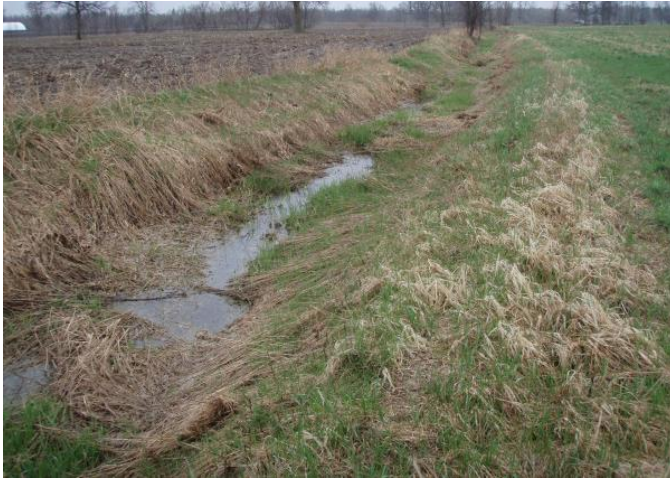
Tributary C of South Huntley Creek is an agricultural drain that runs parallel to William Mooney Road. It flows northwest and is intercepted by the first and second tributaries discussed approximately 400 m south of Richardson Sideroad. This tributary has been highly altered by historical agricultural land use and is subject to current impacts resulting from adjacent crop farming. It is a linear channel dominated by shoreline grasses and some sedges (**Plates 3 and 4**). Trees occur randomly along the channel but provide very little shading to the watercourse. There are no pool or riffle habitats present in this tributary. South of the inflow of Tributaries A and B, Tributary C had no

discernable flow during AECOM's investigations, despite an abnormally wet period preceding the Site visit. The channel north of that point contained flow, largely originating from tributaries A and B.

Plate 3. Tributary C displaying agricultural channel, south of property laneway upstream from the confluence with Tributary A and B.

Based on these preliminary investigations, it appears that the tributary functions solely as an agricultural drain and does not provide fish habitat. Ongoing agriculture, including crop planting up to top of bank will further impair the tributary and its water quality.

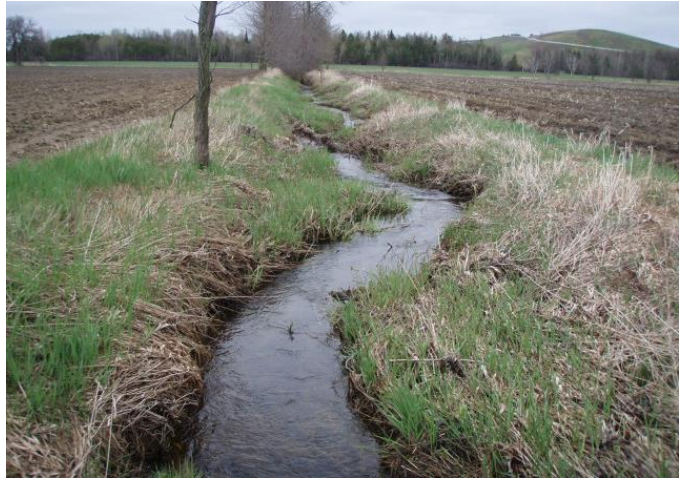
Plate 4. Tributary C displaying agricultural channel, northwest of property laneway, downstream of the confluence with Tributary A and B.
